## **FACE INVESTIGATION**

### **SUBJECT: Supervisor at Plastics Company Crushed in Injection Molding Machine**

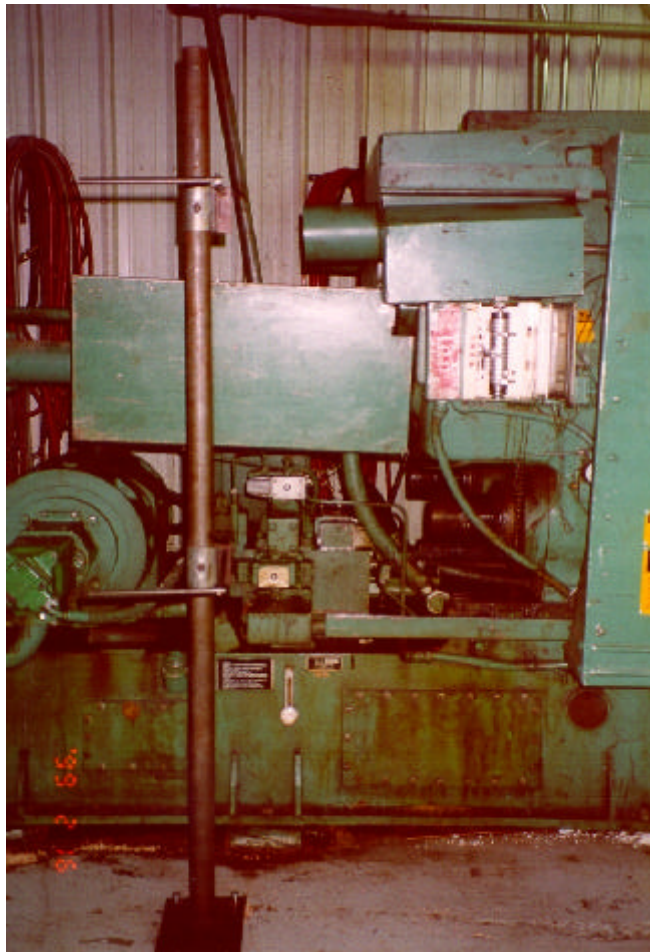
Discussion: Machine guards are necessary where pinch points are created by moving machinery parts. Guards had been removed and not replaced on the machine several weeks prior to the incident, while the company waited for an off-site maintenance worker. In the interim, the company ran the machine for jobs that could be performed without repairs. The incident would have been prevented if the guards were in place while the machine was running.

Figure 1. This photo was taken after the machine guards were replaced.

### **Recommendation #1: Employers should maintain guards in place over machine pinch points when machines are operating.**
